Job No. 88175
Report No.: 1
Revision: 0

**SEISMIC RELIABILITY STUDY OF THE
SEATTLE WATER DEPARTMENT'S
WATER SUPPLY SYSTEM**

Seattle Water Department
Dexter Horton Building
710-2nd Avenue
Seattle, Washington 98104

Cynga Energy Services
2121 N. California Blvd.
Walnut Creek, California 94596

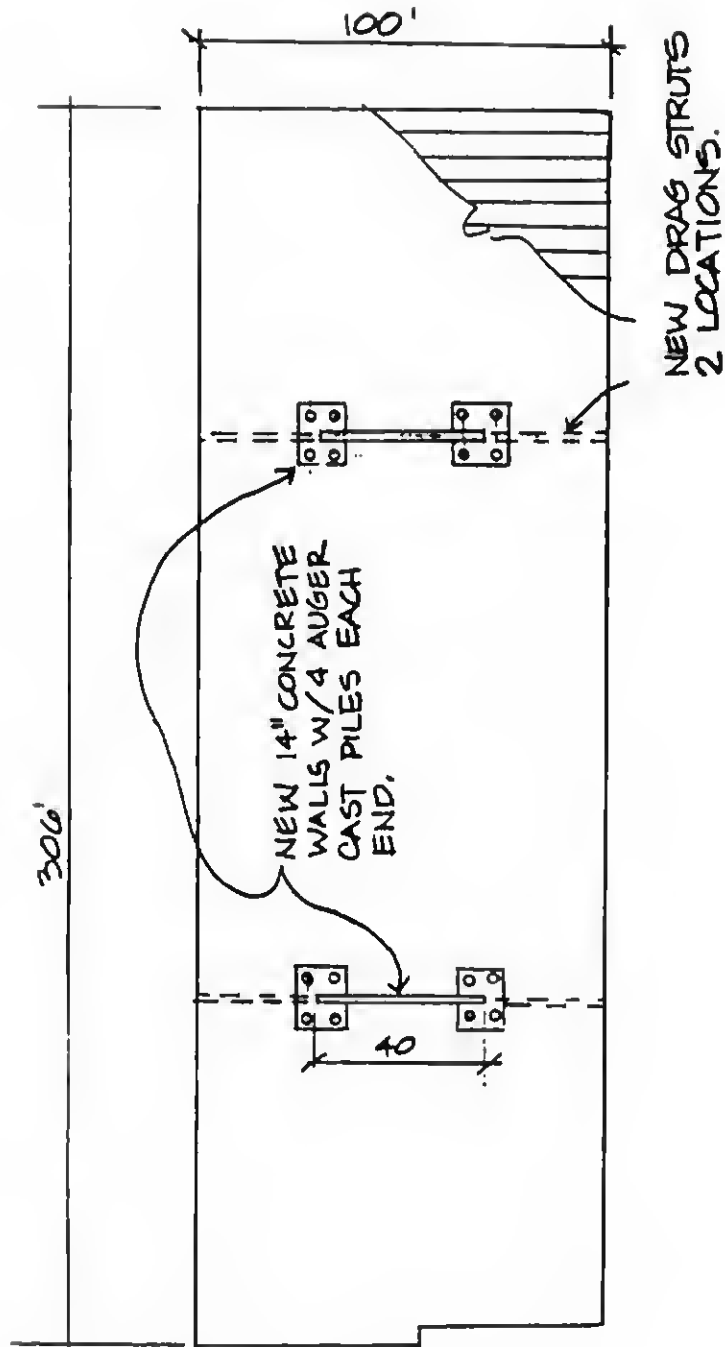
Figure 10.4-1

The Warehouse Building was constructed in 1972 and is located adjacent to the Administration Building on the south side. The building, shown in Figure 10.4-1, is rectangular with an East-West dimension of 100 ft. and a North-South dimension of 300 ft. The roof height is 22 ft. 6 in. The building foundation system is composed of a pile system supporting the columns and structural slab. The roof is constructed of prestressed single tees which span 100 ft. The flange portion of the tee forms the roof deck with no topping slab. The tees are supported on precast perimeter beams. The tilt up precast panels which form the exterior cladding of the building and function as shear walls tie into the perimeter beams and the structural slab.

- d) The interior contents of the building, with the above modifications described for the storage racks, should adequately resist the design earthquakes. The 150-lb. chlorine cylinders located near the outside south wall of the Warehouse Building should be more properly secured.

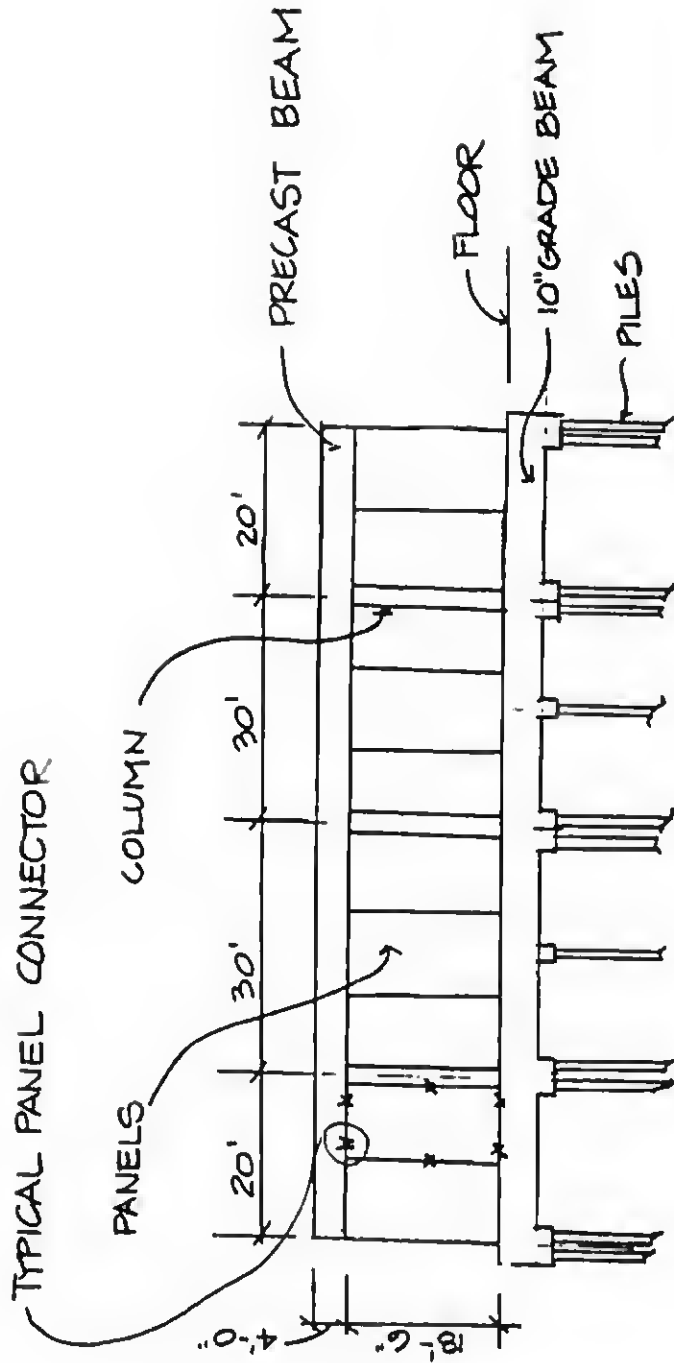
The precast wall panels, 18.5 ft. high by 10 ft. wide, are connected to the gravity structure at six locations, two connectors at the panel top to the spandrel beam, one each side to either adjacent panel or column, and two at the base of the panel to the structural slab. See Figure 10.4-2 for the south wall layout. The top and side connectors are composed of embedded threaded inserts, bolts and plates. The bottom connectors are bent reinforcing steel which is welded to a mating piece protruding from the slab. The panels appear to be designed to act independently, placing the bottom connector in both shear and tension. The weld is then stressed both longitudinally and transversely. The base connectors are the weakest link in that the failure mechanism is the weld being stressed in tension and in shear. This problem is magnified by the possible embrittlement of steel caused by welding on areas where the reinforcing steel is bent.

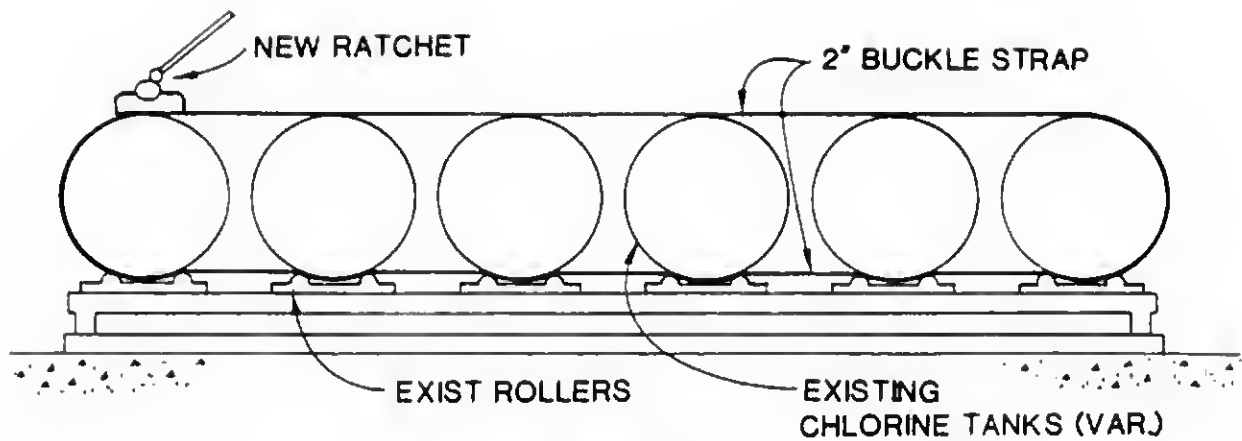
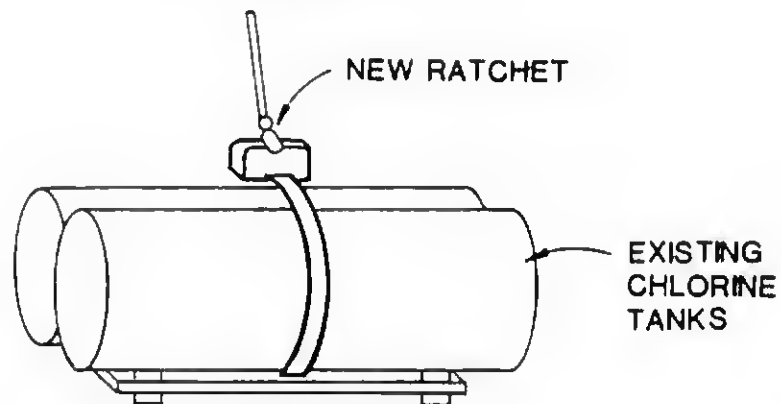
Securing Chlorine Tanks - Strap and Ratchet Arrangement

A common potential hazard was found in the chlorination facilities. The large chlorine tanks, supported on racks over scale pits, are not secured. The chlorine tanks could slide off their racks in an earthquake, rupturing the pressurized feeder lines and causing leakage of chlorine gas. Two alternative methods have been proposed for securing the tanks. The first is to wrap a strap around the tanks and tighten with a ratchet. The second is to construct removable reinforced bollards at each end of the tank racks, along with tube steel rail headers which are parallel to the tank rack on both sides. Either of these methods would prevent the tanks from sliding far enough to sever the feeder lines. The costs projected for securing the chlorine tanks in this report assume that both methods are used in combination.

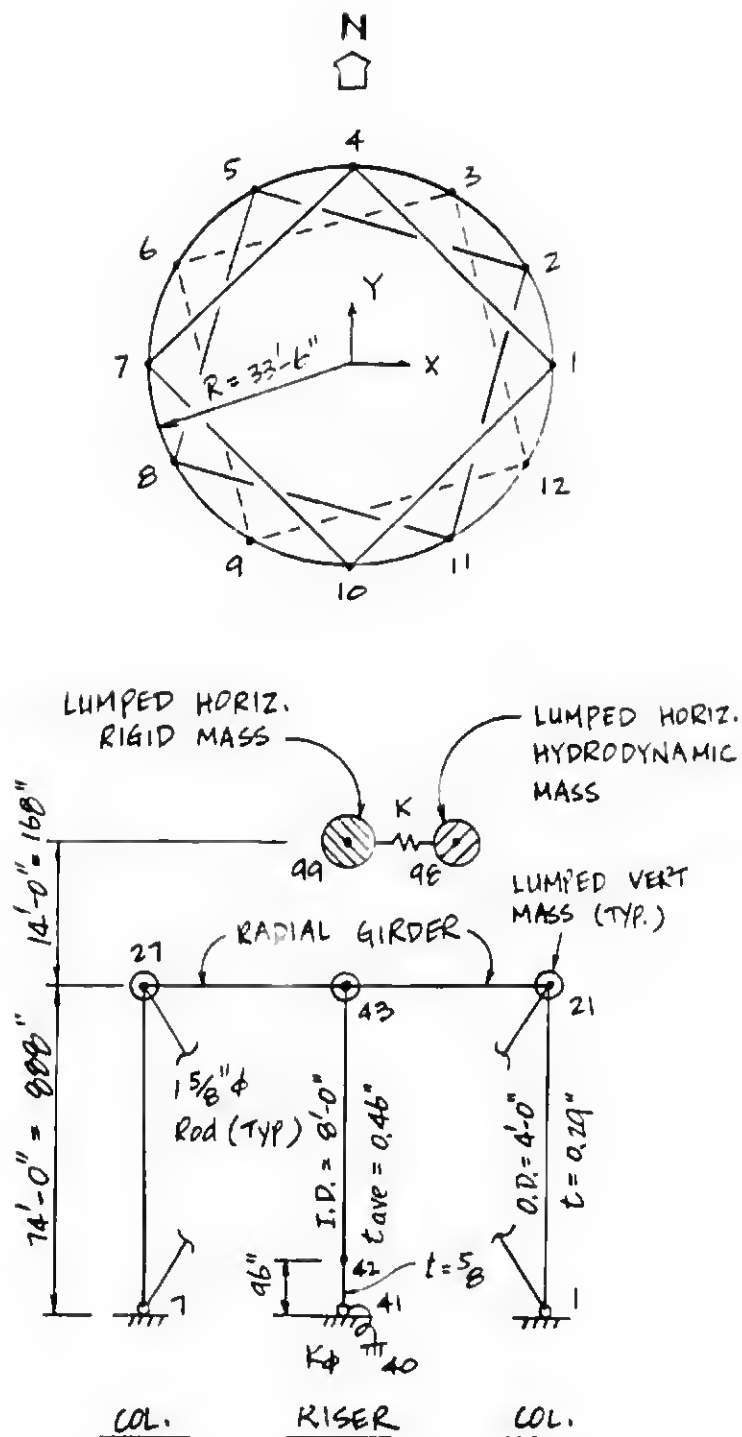
Figure 14.4-3

The computer program ANSYS was used in the analysis. The three dimensional model is shown in Figure 14.4-3. The tank shell connection at the top of the columns was modeled by coupling the horizontal radial beams to the top of the columns, and using constraint equations to couple the horizontal displacements without further restraining the rotations. This assumption is justified because at those connections forces are transferred primarily by shear along the tangential surface of the tank. Along this tangential direction the tank shell is very rigid.

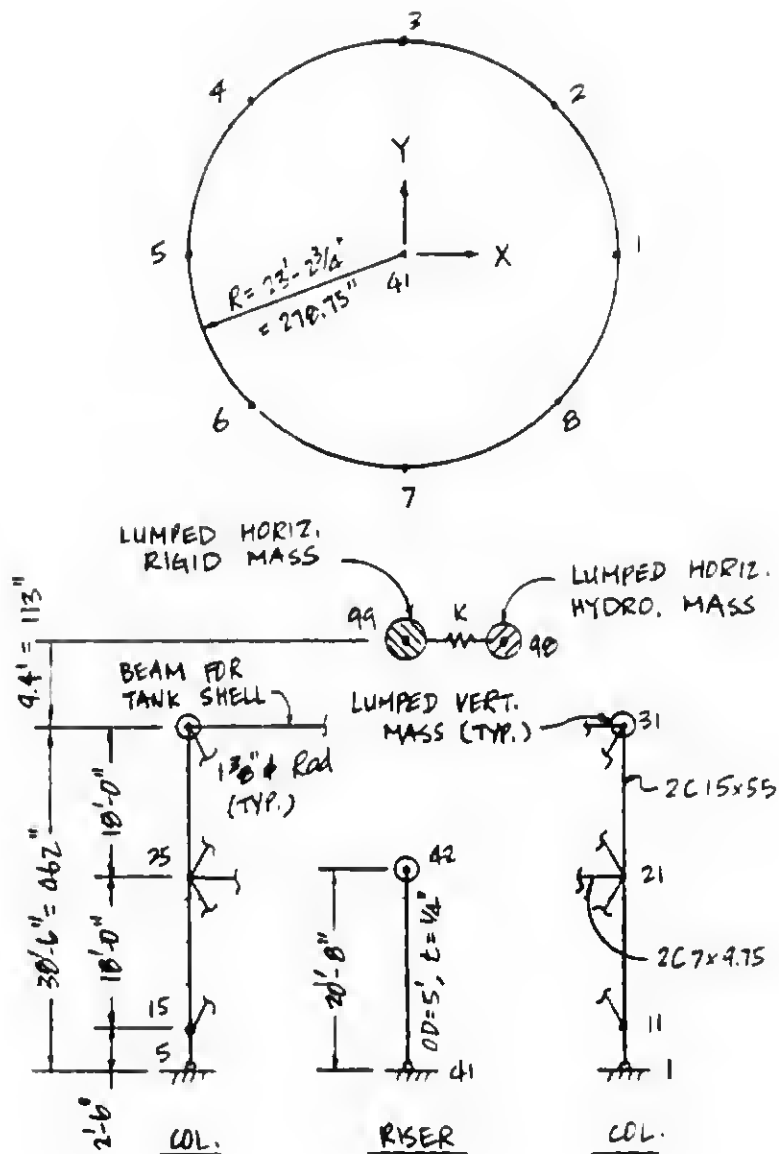
Figure 14.6-3

The computer program ANSYS was used for analysis of the tank. Using this program, a three dimensional model of the tank was developed as shown in Figure 14.6-3. The tank shell connection at the top of the columns was modeled by coupling the horizontal displacements at the top of the columns, and using an equivalent ring beam to restrain the rotations. The connections at the base of each column and the riser are modeled as hinges.

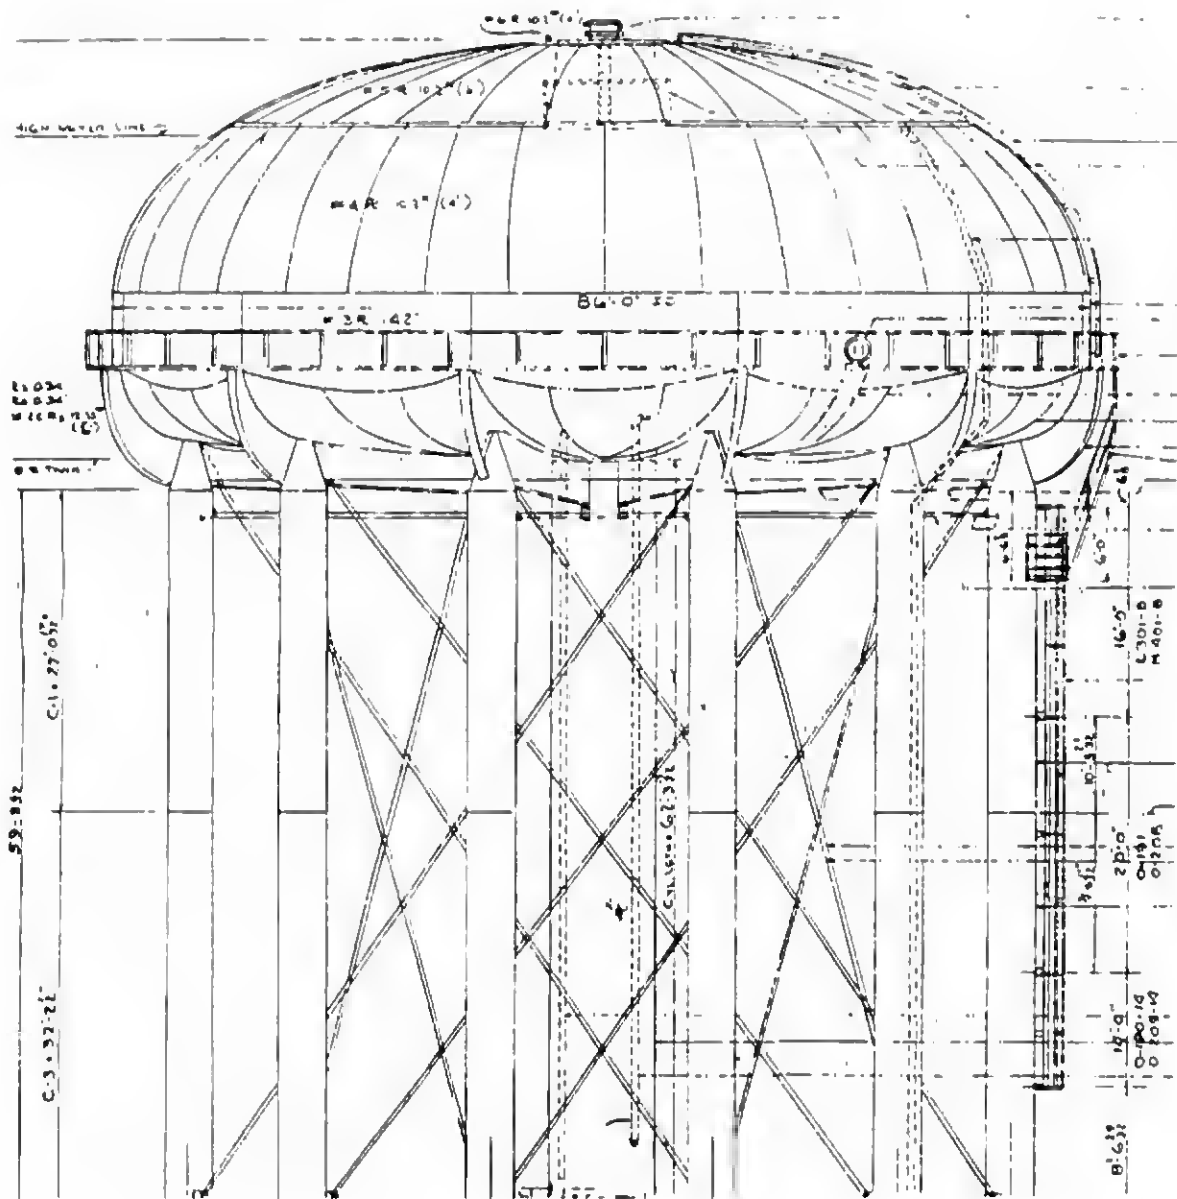
Figure 14.8-1

The Richmond Highlands #1 elevated water storage tank, built in 1954, has a capacity of 1,000,000 gallons. The structure is shown in Figures 14.8-1 to 14.8-4. The elevated tank shell is supported by radial girders resting on twelve (12) braced columns with a diameter of 48 in. and a cross sectional area of approximately 43 sq. in. The braces have a cross section of 7 sq. in. There is a central riser with a diameter of 96 in. and a cross section of approximately 139 sq. in. The columns are supported by spread footings with no tie beams.

Richmond Highlands #1 Elevated Water Storage Tank
Elevation View

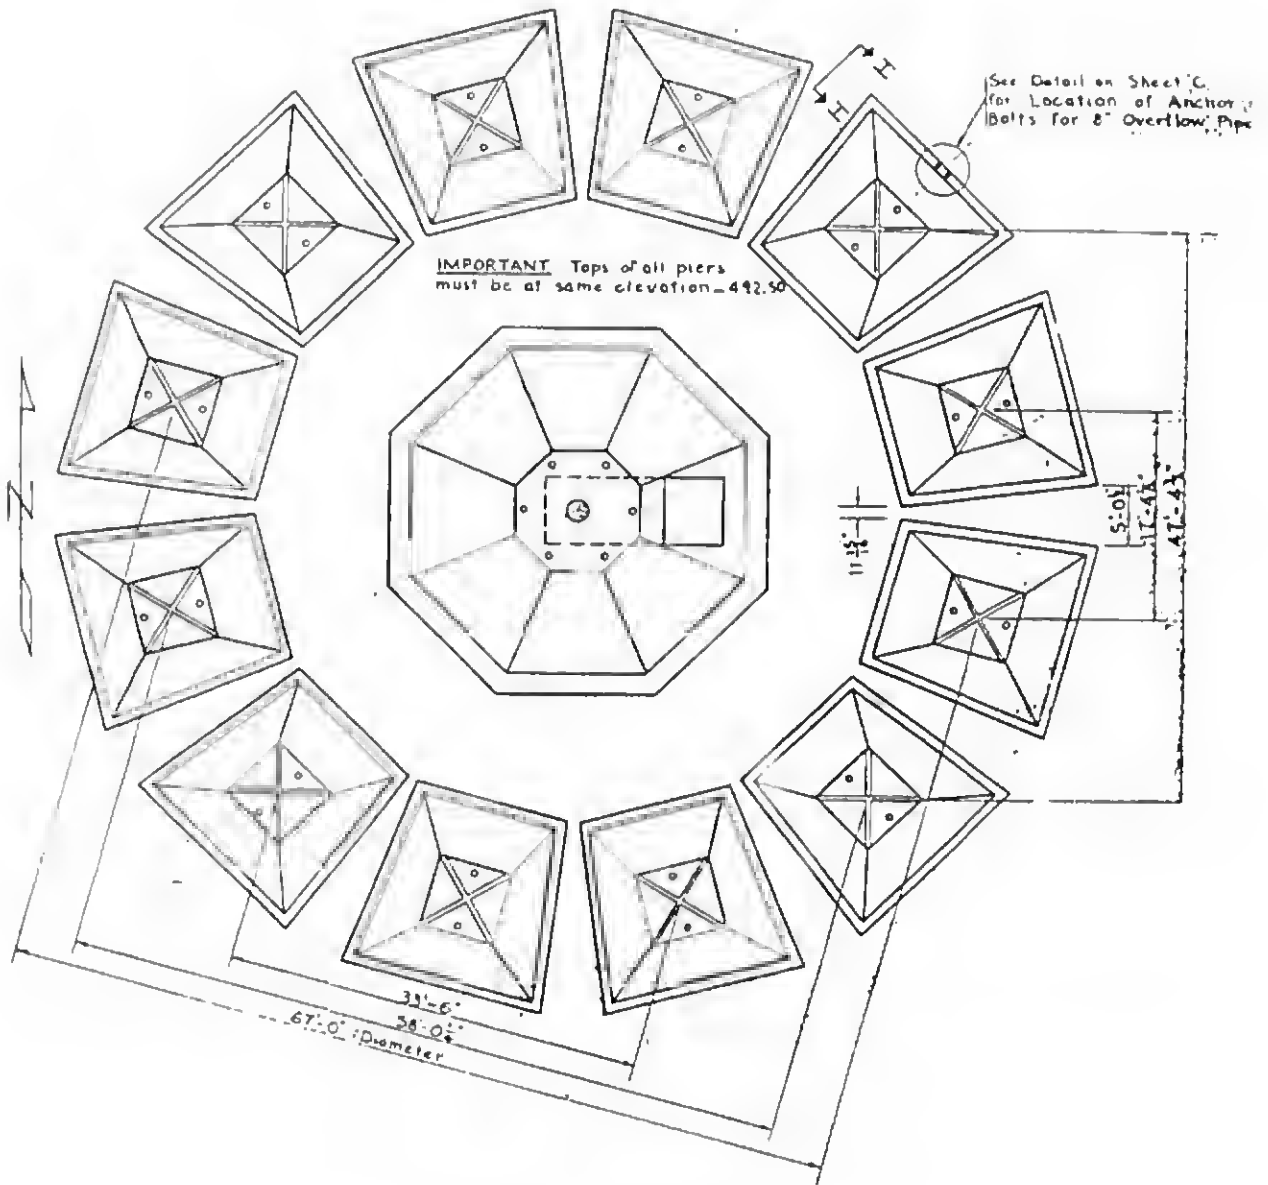
Figure 14.8-2

**Richmond Highlands #1 Elevated Water Storage Tank
Plan View**

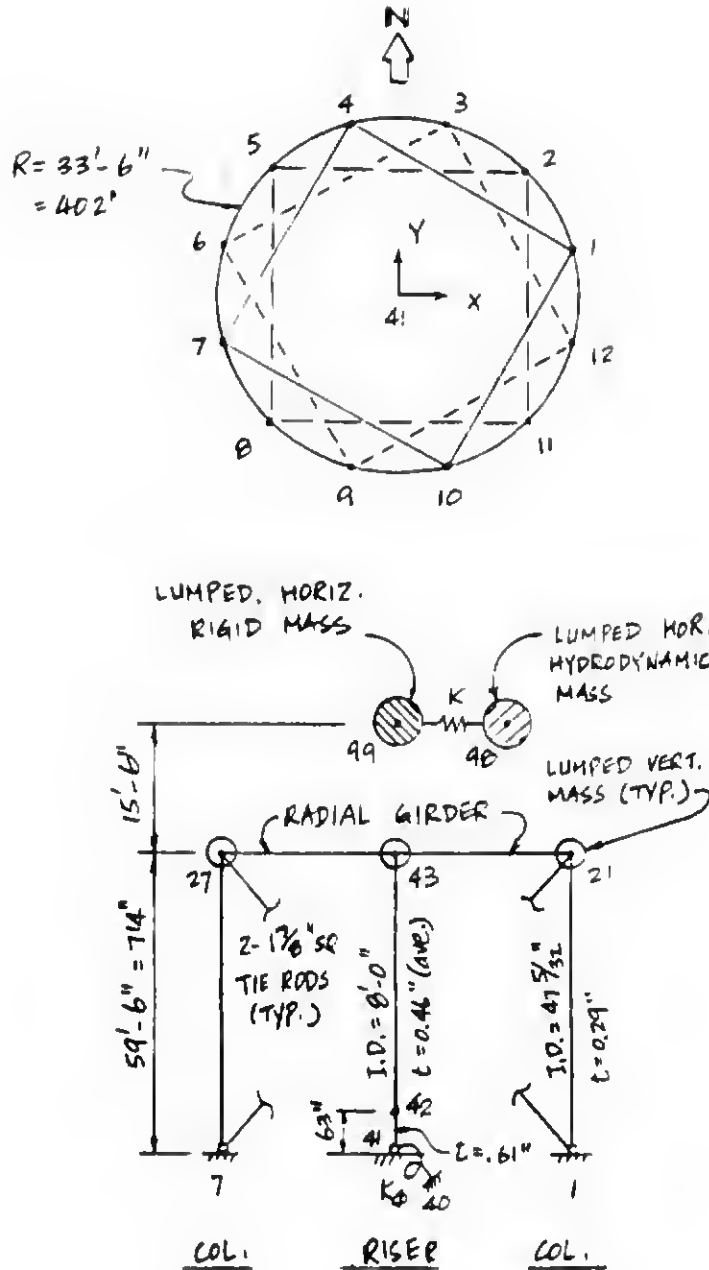
Figure 14.8-3

The computer program ANSYS was used in the analysis. The three dimensional model is shown in Figure 14.8-3. The tank shell connection at the top of the columns was modeled by coupling the horizontal radial beams to the top of the columns, and using constraint equations to couple the horizontal displacements without further restraining the rotations. This assumption is justified because at those connections forces are transferred primarily by shear along the tangential surface of the tank. Along this tangential direction the tank shell is very rigid.

Richmond Highlands #1 Elevated Water Storage Tank
Mathematical Model

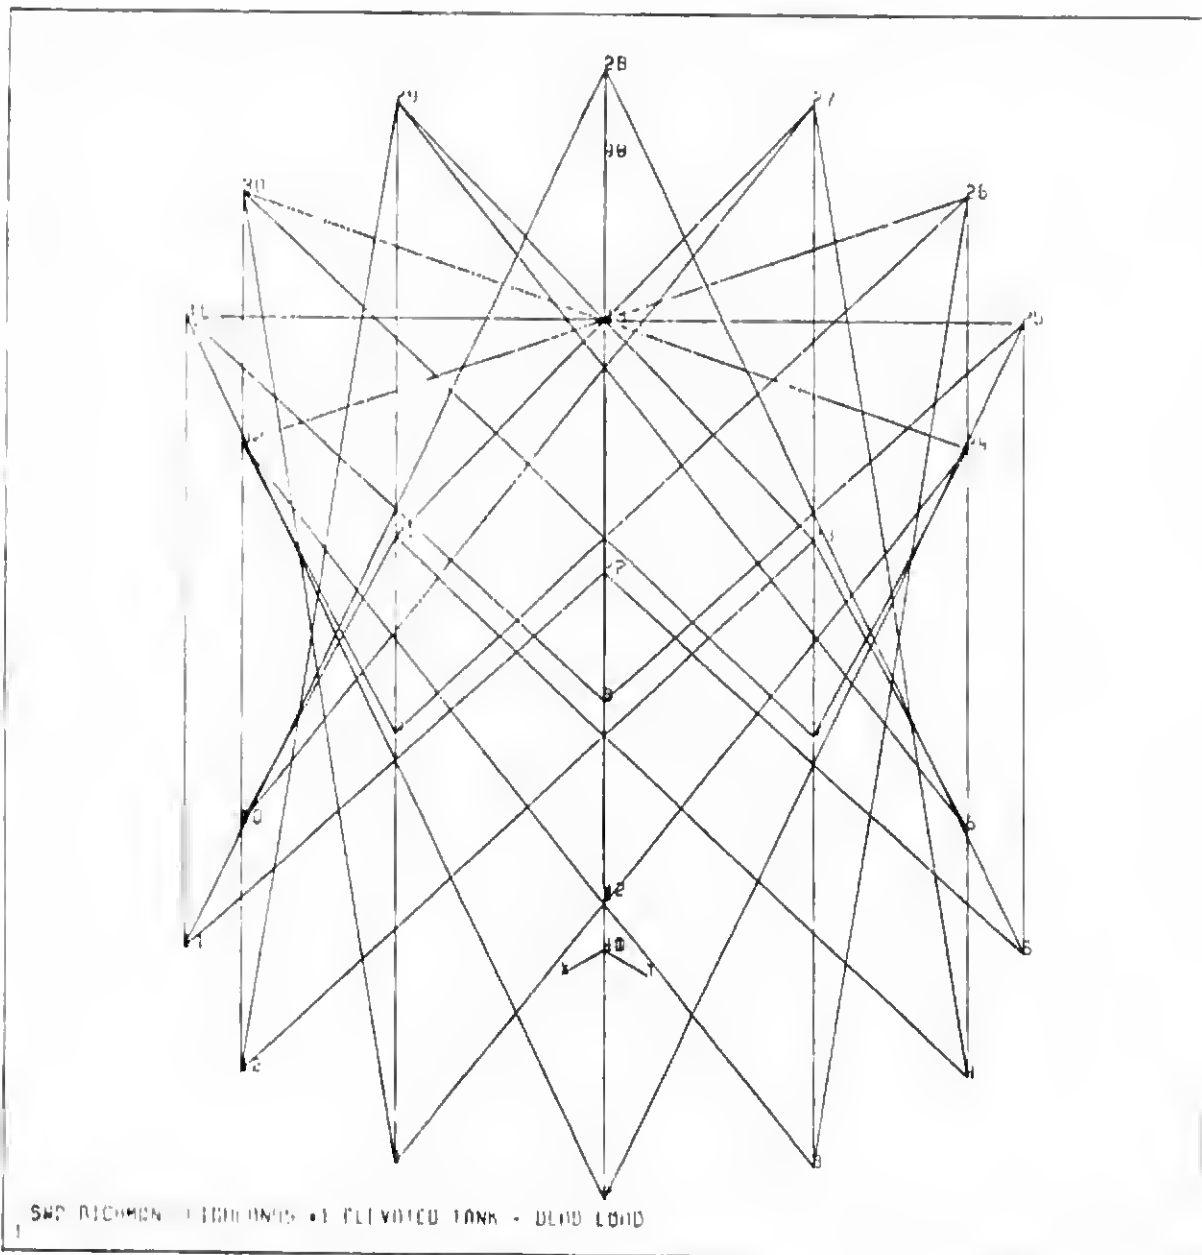
Figure 14.8-4

**Richmond Highlands #1 Elevated Water Storage Tank
Computer Plot**

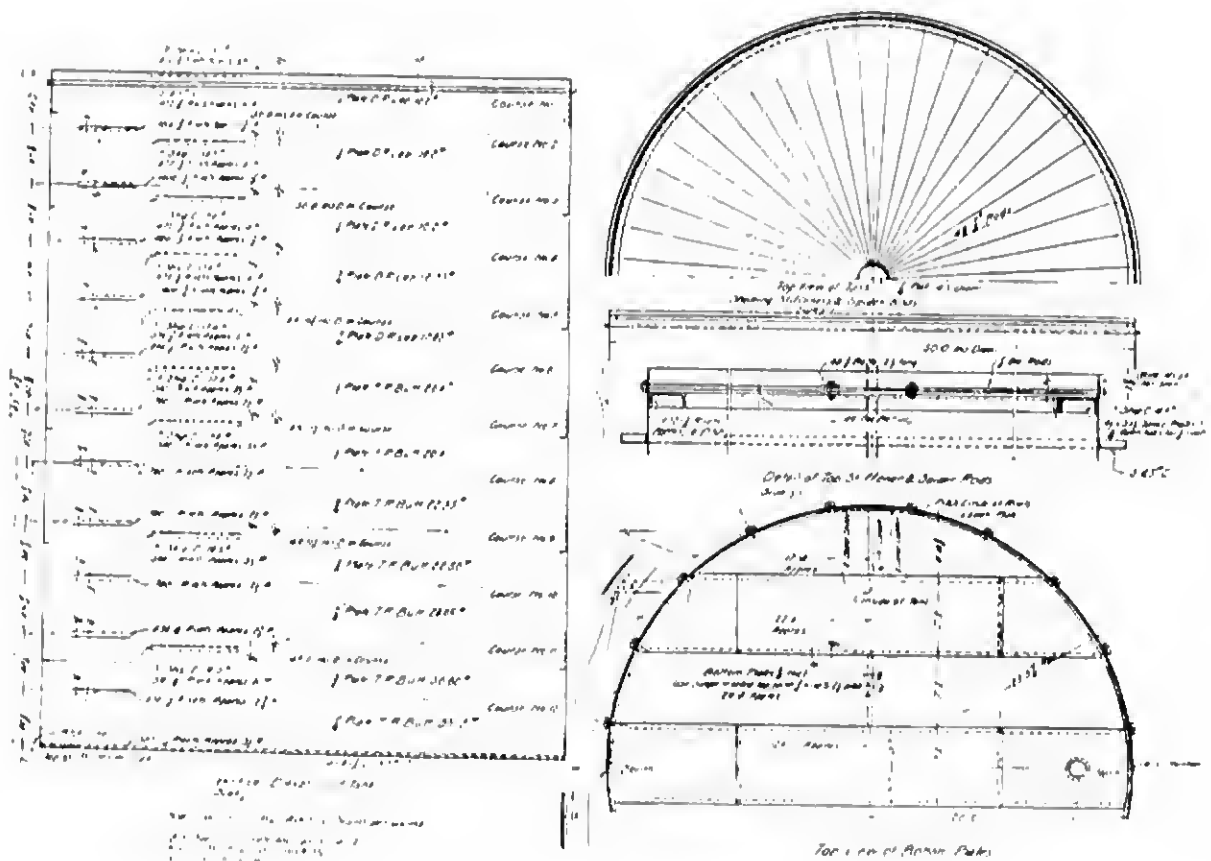
Figure 15.4-1

The Charlestown water storage standpipe, constructed in 1927, has a capacity of 883,000 gallons. The structure is shown in Figure 15.4-1. The structure has a diameter of approximately 50 ft. and a height of 62 ft. The cylindrical shell ranges in thickness from 1/4 in. to 13/16 in. The bottom plate is 5/16 in. thick. The tank is supported on a mat foundation, assumed to be 4 ft. thick and 56 ft. in diameter. Anchorage is provided by twenty 2 in. diameter bolts with 3 ft. 6 in. embedment.

Charlestown Water Storage Standpipe

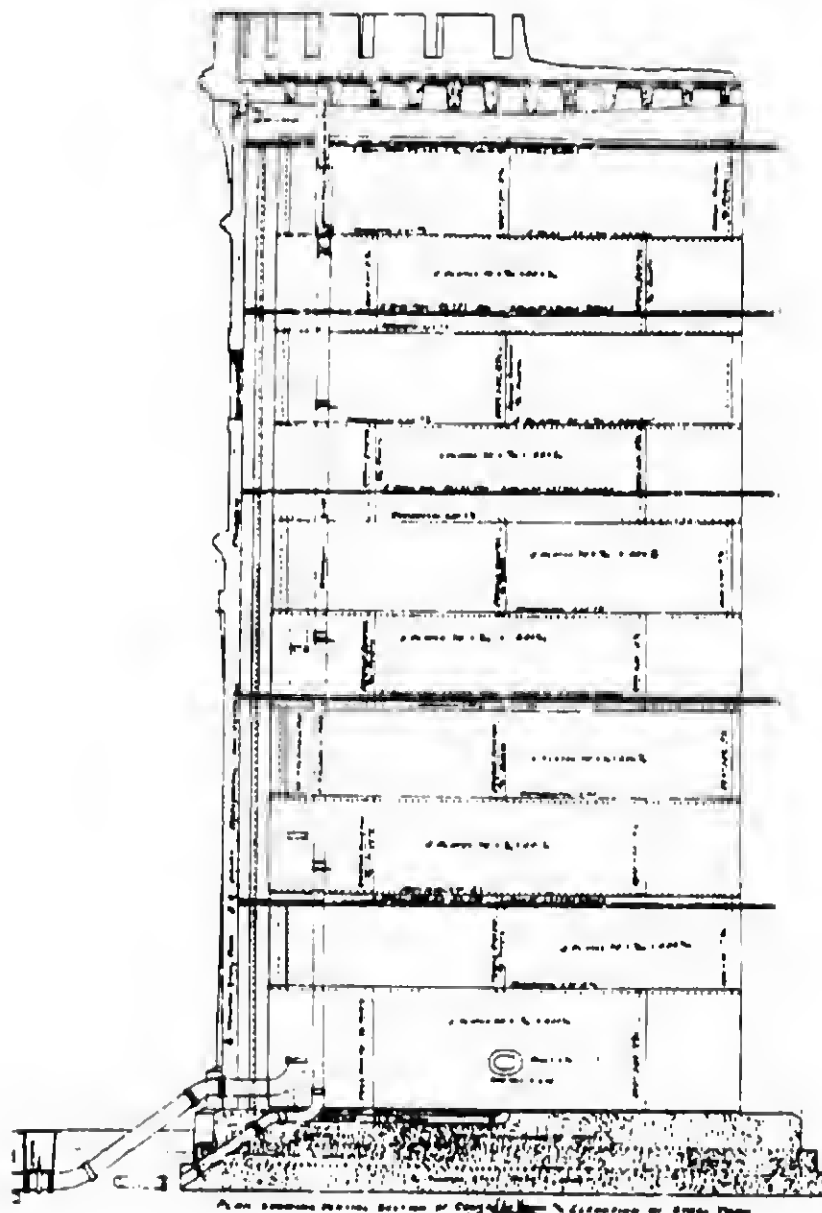
Figure 15.6-1

The Queen Anne #1 water storage standpipe, constructed in 1901, has a capacity of 318,000 gallons. The structure is shown in Figure 15.6-1. The standpipe has a diameter of approximately 30 ft. and a height of 64 ft. The cylindrical shell ranges in thickness from 1/4 in. to 5/8 in. The bottom plate is 1/4 in. thick. The tank is supported on a mat foundation, 1-1/2 ft. thick and 42 ft. in diameter. Anchorage is provided by eight (8) 1-1/4 in. diameter bolts with 3 ft. 6 in. embedment.

Queen Anne #1 Water Storage Standpipe

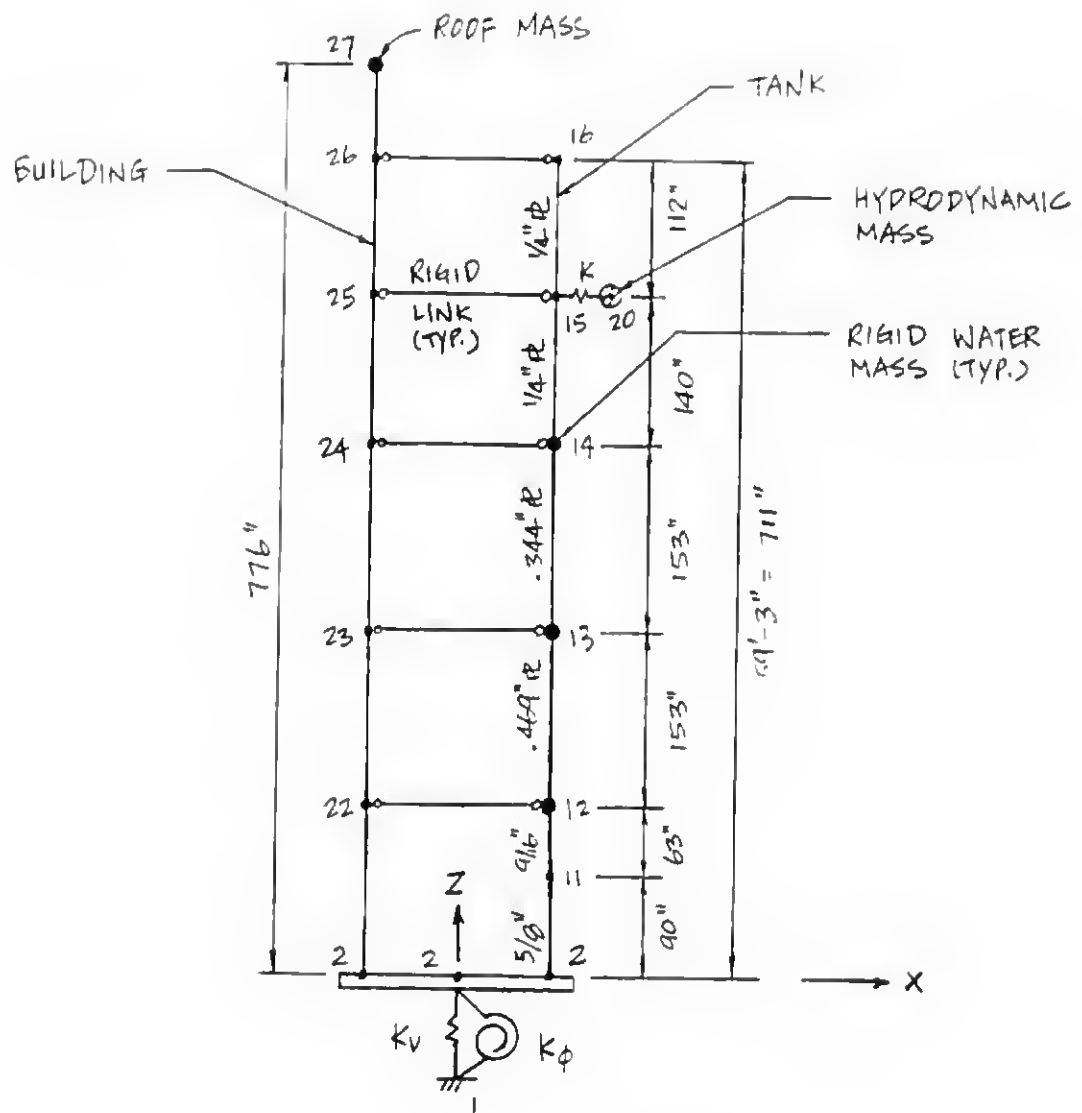
Figure 15.6-2

The computer program ANSYS was used for the analysis. The simplified model is shown in Figure 15.6-2. It should be noted that standpipes are "short period" structures and thus, any modeling assumptions which underestimate their rigidity are non-conservative because they can result in artificially lower spectral accelerations. The effect of soil-structure interaction cannot be ignored. The flexibility of the soil will increase the period of the standpipe and introduce a larger spectral acceleration.

Queen Anne #1 Water Storage Standpipe
Mathematical Model

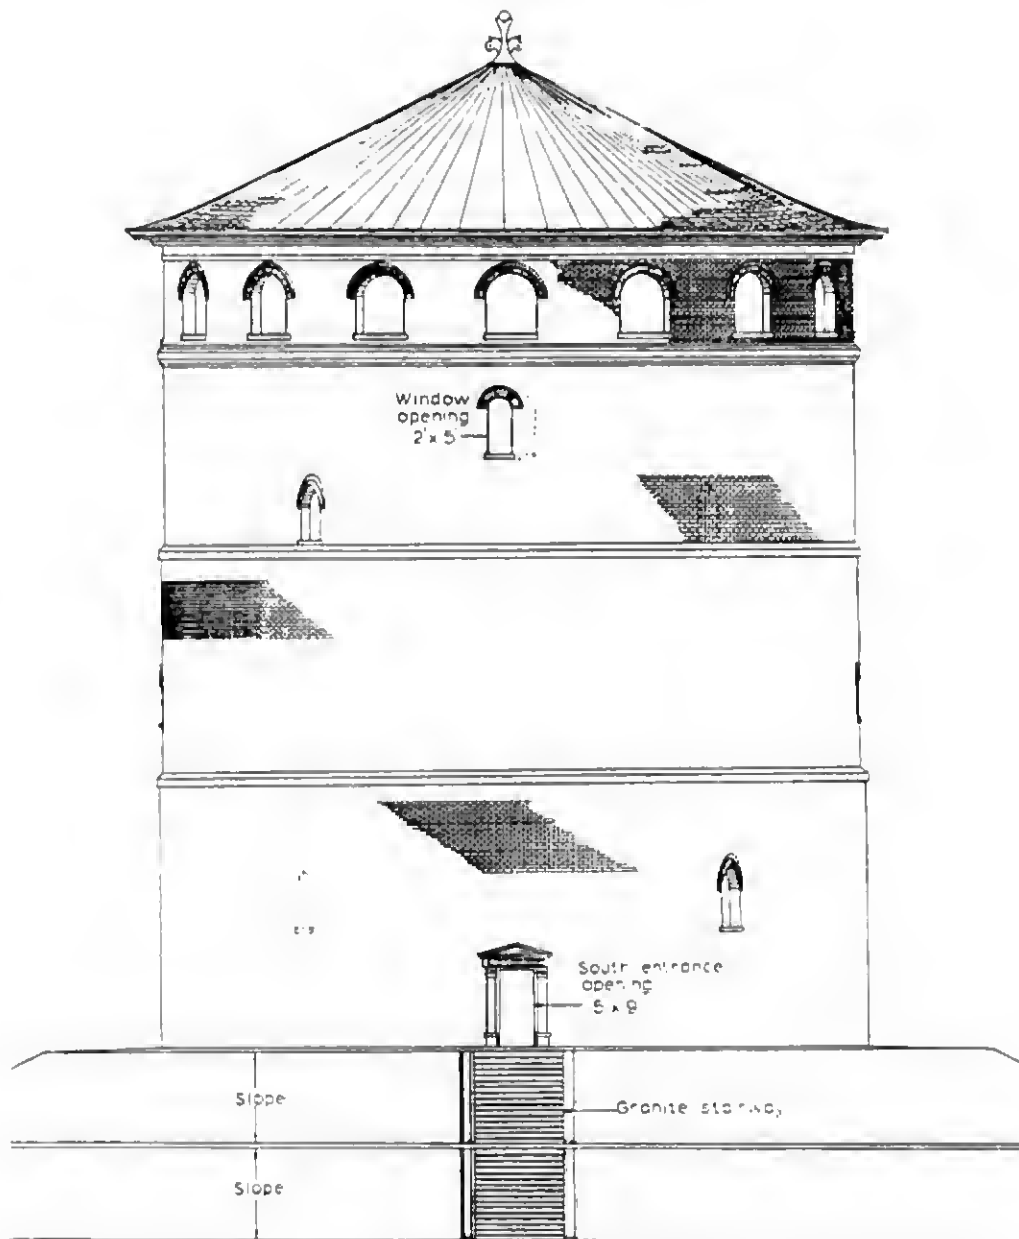
Figure 15.9-1

The Volunteer Park water storage standpipe, constructed in 1907, has a capacity of 883,000 gallons. The structure, shown in Figure 15.9-1, has a diameter of approximately 50 ft. and a height of 66 ft. The cylindrical shell ranges in thickness from 5/16 in. to 15/16 in. The bottom plate is 1/2-in. thick. The tank is supported on a mat foundation, 2-1/2-ft. thick and 70-ft. in diameter. Anchorage is provided by eight (8) 1-1/4 in. diameter bolts.

Volunteer Park Water Storage Standpipe

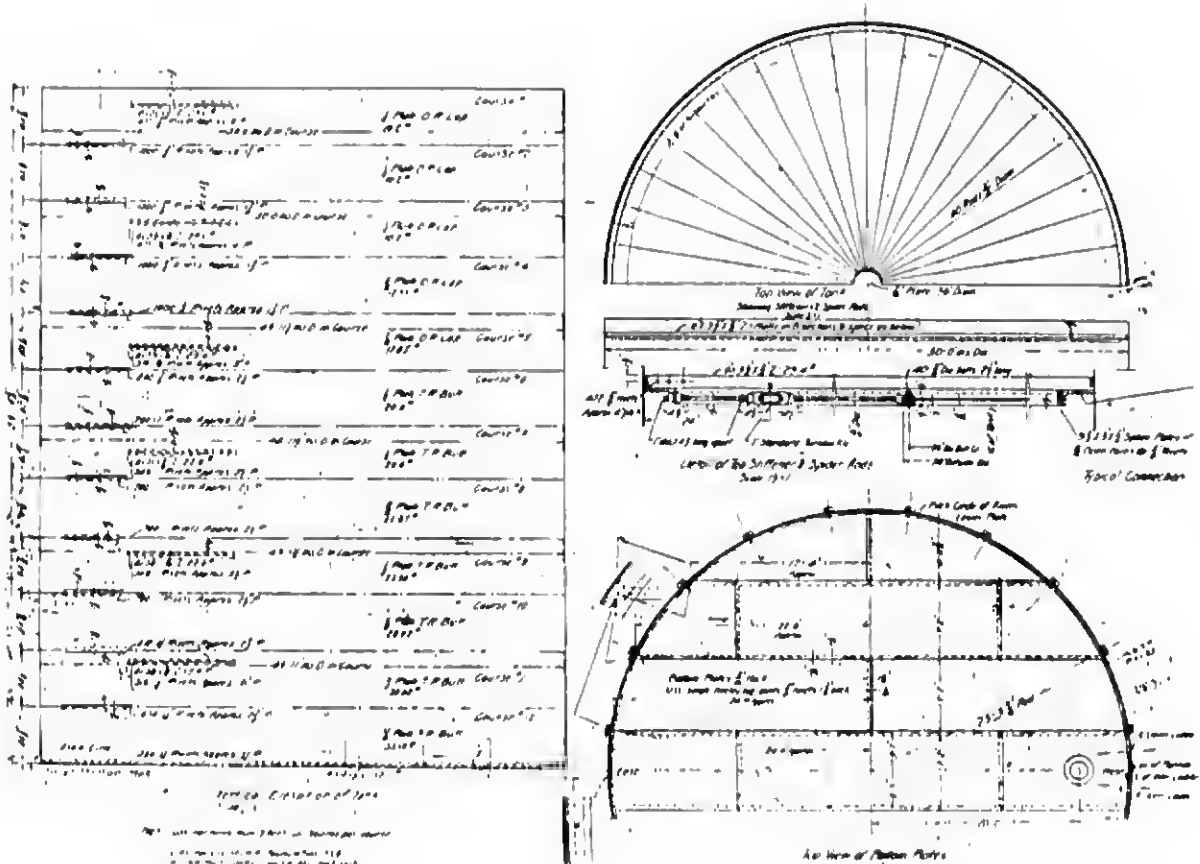
Figure 15.10-1

The Woodland Park water storage standpipe, constructed in 1925, has a capacity of 1,000,000 gallons. The structure, shown in Figure 15.10-1, has a diameter of approximately 50 ft. and a height of 75 ft. The cylindrical shell ranges in thickness from 1/4 in. to 3/4 in. The bottom plate is 5/16-in. thick. The tank is supported on a mat foundation, assumed to be 2-ft. thick and 52-ft. in diameter. Anchorage is provided by twenty (20) 1-1/2-in. diameter bolts with 3 ft. 6 in. embedment.

Woodland Park Water Storage Standpipe
